Minerals Inspection Report

Mine Name: Asphalt Ridge 2	Permit Number: M/47/0032	Mine Status: Inactive
Operator Name: Tar Sands Holdings II	Inspection Date: 05/27/2015	Permit Fees: Delinquent
Inspector(s): A. Abate	Inspection Time: 8 AM	Bond Amount: \$376,000
Attendee(s):	Weather: Clear	Bond Escalation:
Inspection Purpose: Oversee reclamation work at adjacent exploration permit E/47/0066		Prior Inspection: 11/18/2013

Asphalt Ridge 2 M/47/0032

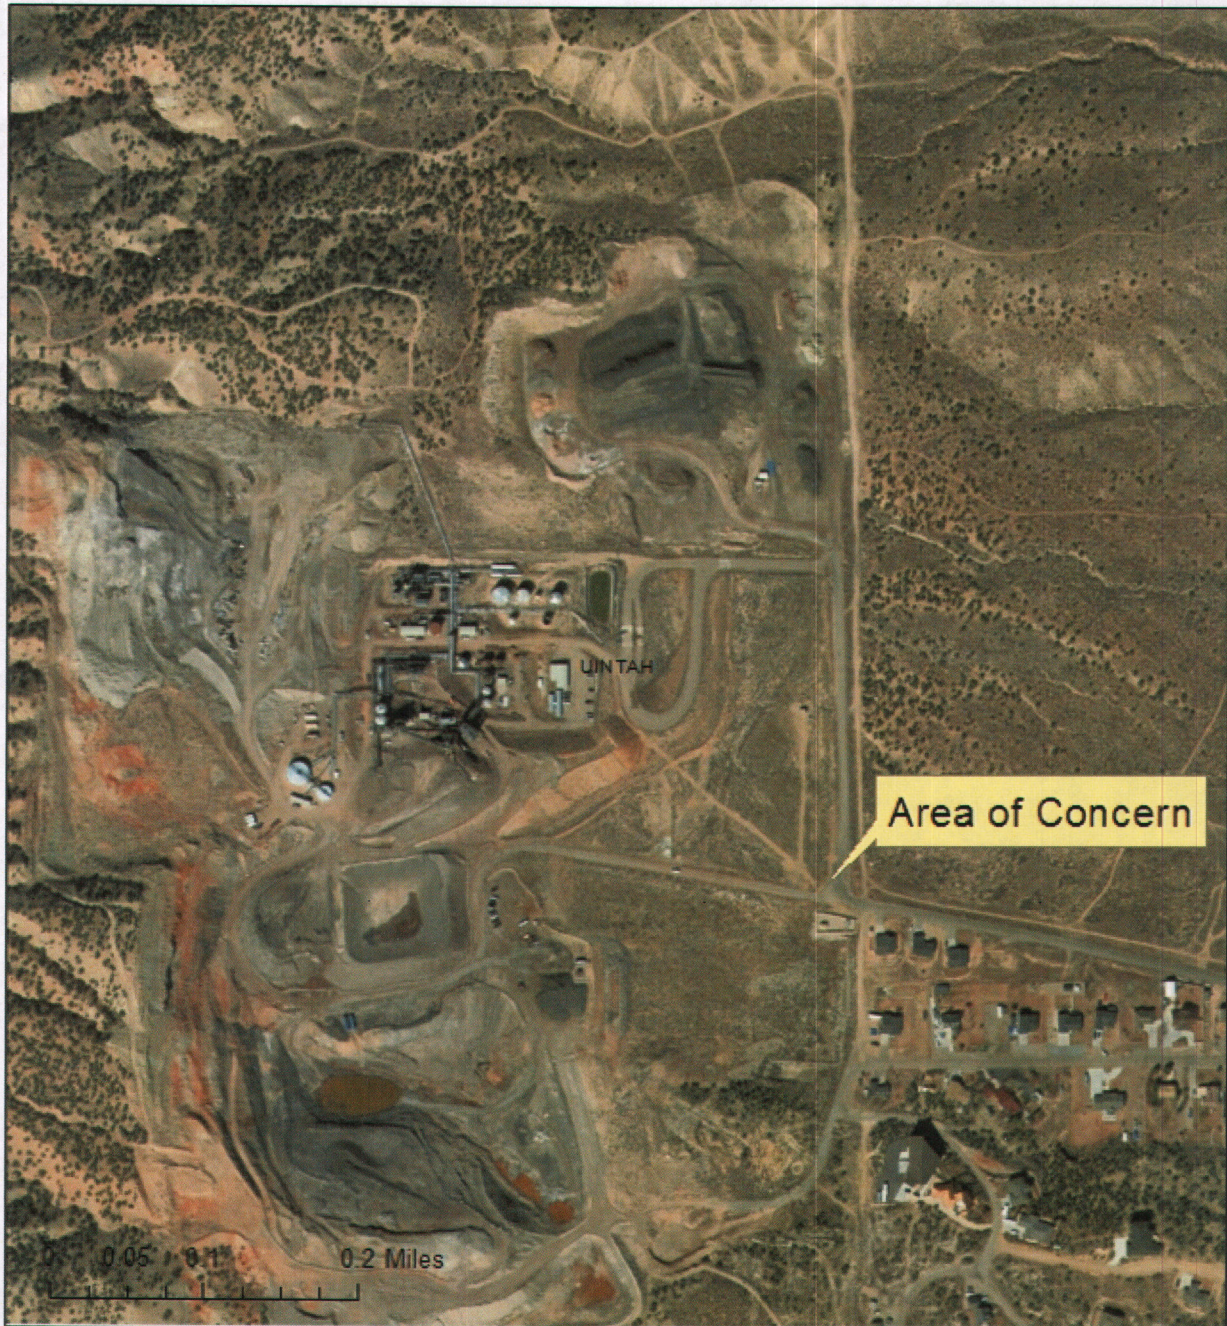
4. <i>Deleterious Material</i>	<input checked="" type="checkbox"/>	<input checked="" type="checkbox"/>
Noticed off-site sediment deposited beyond the mine gate onto the county road leading to the residential area. The county had placed sand bags along the road a few weeks ago according to Rick, the mine caretaker. The source of the material was from the mine. Sediment control is not being maintained on the mine property. A notice of violation is warranted for failure to maintain adequate sediment control. Other areas within the mine are also experiencing major erosion problems. Large rills are forming leading to the existing sediment ponds. Ditches alongside the roads are not being maintained. Culverts are not being maintained. Drainage issues noted in the previous inspection report dated 11/18/2015 do not appear to have been corrected.

Notice of Violation MN-2015-60-02 was issued requiring the operator to address sediment control problems off-site and a plan to maintain sediment control as a commitment to the NOI. The \$500 permit fee for this mine is overdue. A delinquency notice was sent to the operator requiring the fee be paid by 6/30/2015.
